MISCELLANEOUS PAPER S-68-26

# CONDITION SURVEY, DAVISON ARMY AIRFIELD, FORT BELVOIR, VIRGINIA

November 1968

U. S. Army Engineer Waterways Experiment Station  
CORPS OF ENGINEERS  
Vicksburg, Mississippi

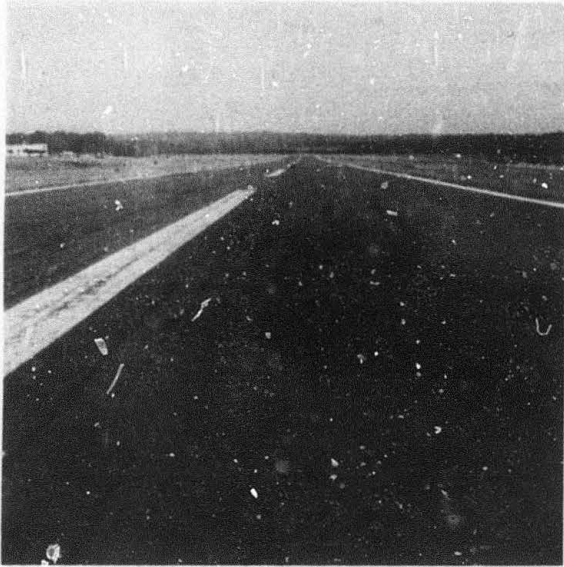
10. In June 1967, the asphaltic surface on the runway was considered to be in fair condition (photograph 1). Some longitudinal and transverse cracking was evident in the pavement. The slurry seal coat placed in 1965 did not cover the cracking and was showing signs of peeling in some areas. The overrun at the northwest side of the runway is now maintained as a mowed area (photograph 2). The parallel taxiway for the fixed-wing facilities was in fair condition (photograph 3). Gouged-out areas caused by H-21 helicopter wheels had been repaired, and similar damage was not reoccurring because the helicopters were operating from the heliport. This taxiway did not receive a slurry seal coat. The fixed-wing parking apron appeared to be in

a. View of runway looking  
southeast

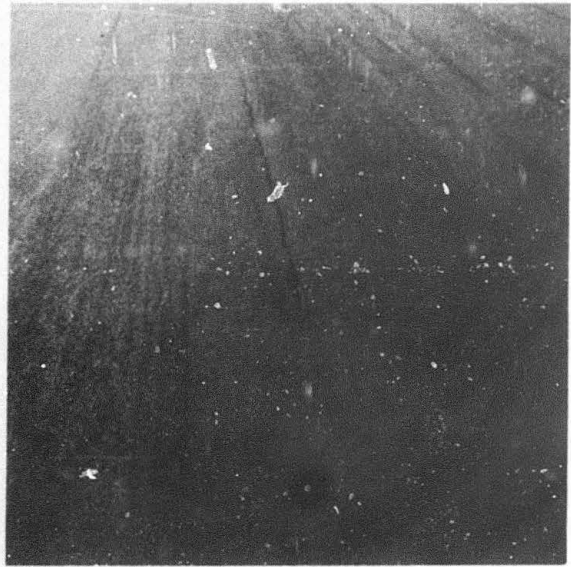
b. Evidence of longitudinal cracking  
on runway surface

Photograph 1. General condition of fixed-wing runway

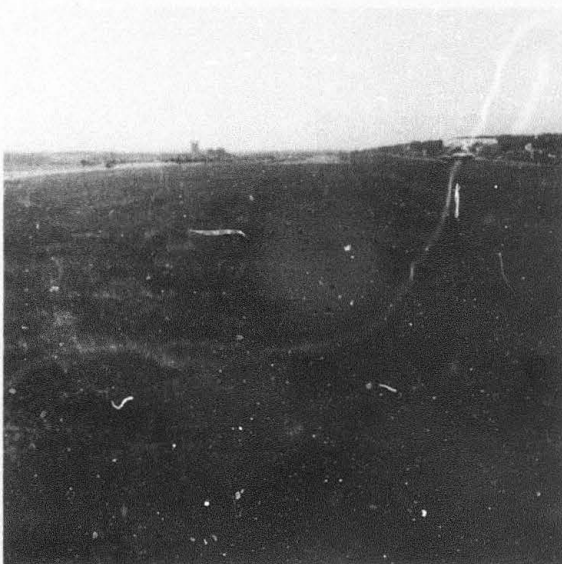
Photograph 2. Bituminous-surfaced overrun at  
northwest end of runway overgrown with grass

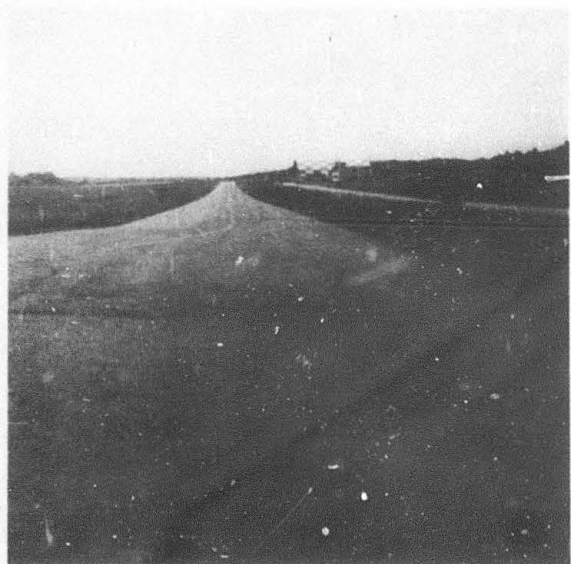
Photograph 3. View of fixed-wing  
taxiway

11. There is a proposal to widen and overlay the existing fixed-wing taxiway probably in FY 1968 or FY 1969. The taxiway is to be widened 15 ft and overlaid with approximately 2 in. of asphaltic concrete.

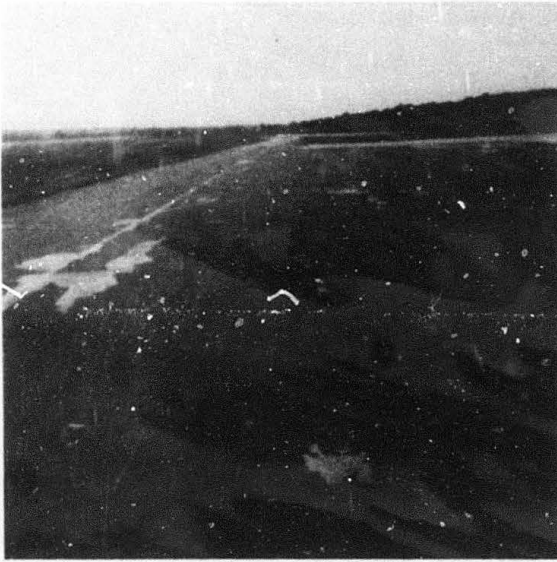
satisfactory condition. The slurry seal coat placed over the portland cement concrete area was peeling badly (photograph 4). The runways and parking apron in the heliport area were in excellent condition, but the parallel taxiway from the heliport area to the northwest end of the runway was in poor condition (photograph 5).

a. Portion of taxiway adjacent  
to parking apron

Photograph 4. Slurry seal coat peeling off portland cement  
concrete portion of taxiway and parking apron

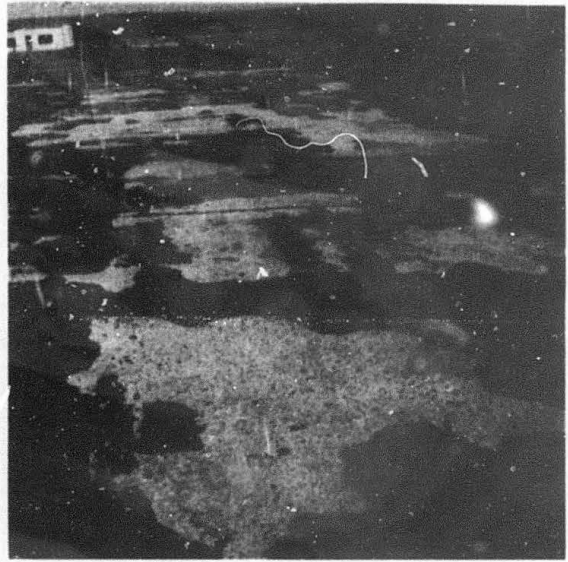
b. Seal coat peeling off portion of  
fixed-wing parking apron

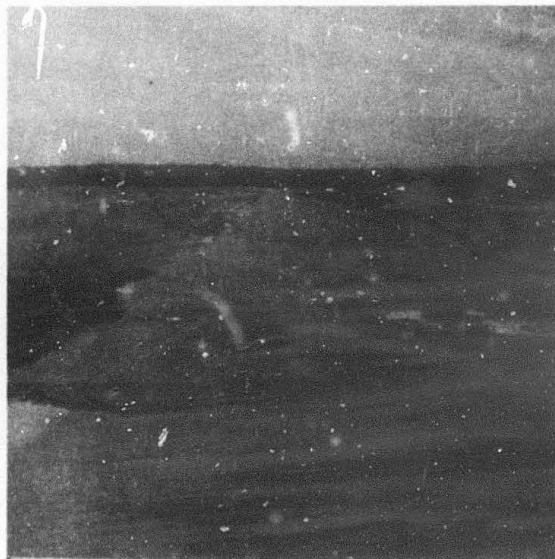
Photograph 5. Taxiway adjacent to heliport area
